# **LAKE MANAGEMENT PLAN FOR BLUE LAKE MINOCQUA, WISCONSIN**

Dan Pagel  
Chairman  
Lake Management Planning Committee  
Blue Lake Preservation Association  
January 2, 2011

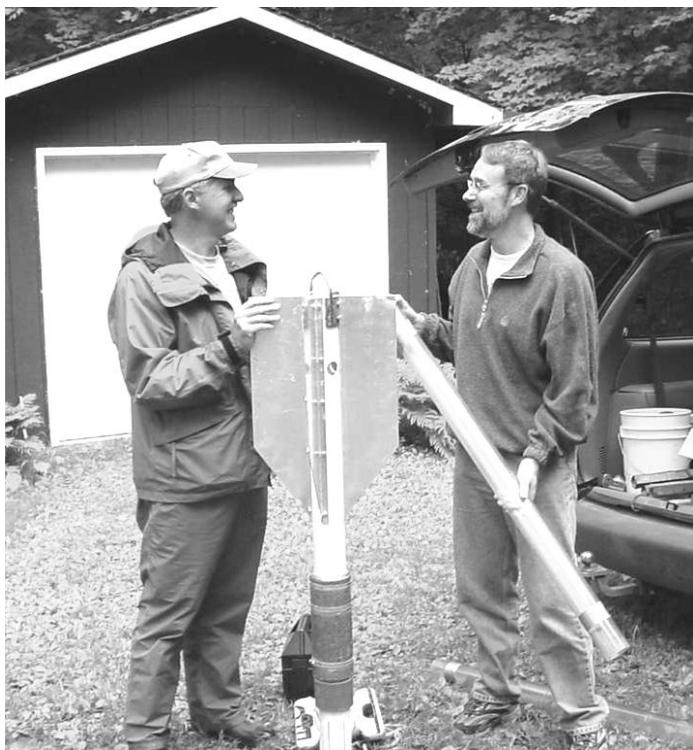
Paleolimnologist Paul Garrison and Blue Lake resident Mark Bergeon preparing to use "the bomb", the piece of equipment with which they will retrieve the core sample from the bottom of Blue Lake.

A paleolimnological assessment of lake sediments (core sample) was conducted in July 2003 to assess water quality changes from pre-settlement conditions through history to present day (Garrison 2003).

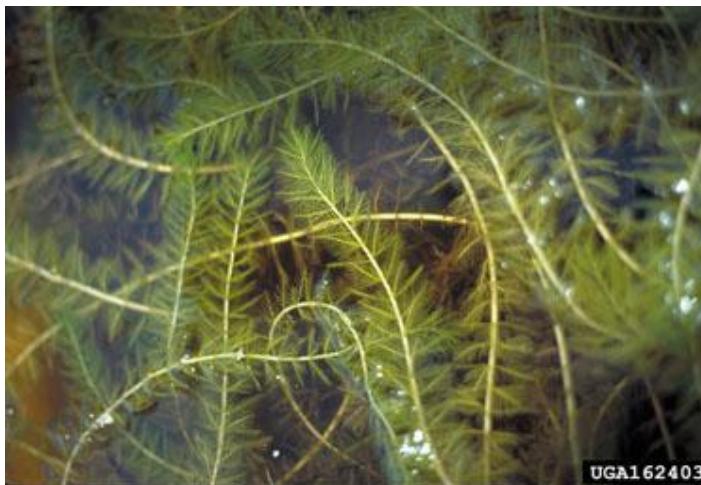
*The aquatic plant survey team did not find evidence of any non-native (invasive) plants during this survey.* It is important, however, for everyone who uses Blue Lake to be aware of the possibility of their introduction. Make sure all boats are not bringing any aquatic invasive species into the lake. When on or in the water, look for evidence of non-native plants. Become familiar with what the most common invasives look like, especially Eurasian Water Milfoil and Curly Leaf Pondweed.

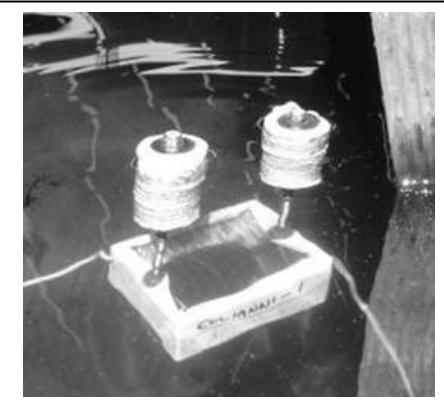
Diatometer to collect algae samples

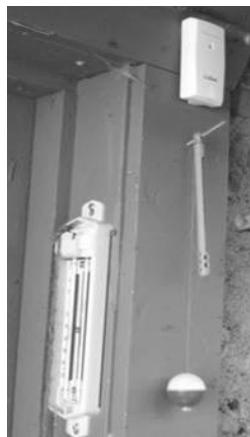
L: Air temperature thermometer;  
R: Total immersion water temperature thermometer
